OLD LINE
HOME INSPECTIONS

Home Inspection Report

123 Main Street

Inspected on Tue, Mar 23 2021 at 5:00 PM

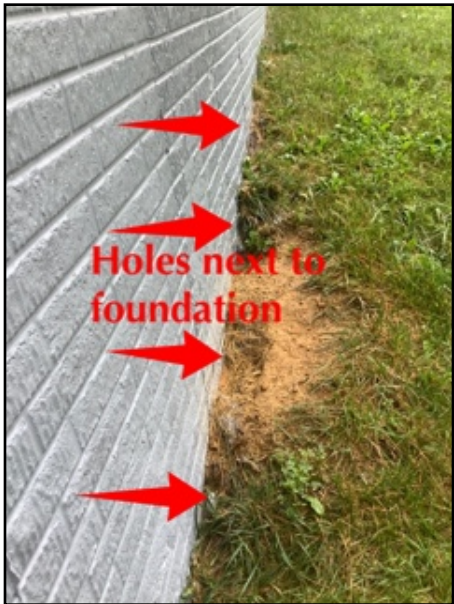
Figure 1-1

Soil has washed away from foundation leaving small holes behind.
Recommend adding fill dirt to divert water and grading soil to slope away from foundation.

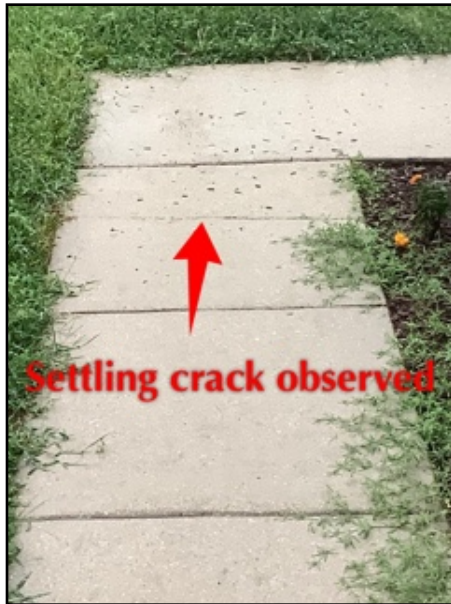
Figure 2-1

Comment 2:
Walkway in front of house has typical settlement cracking. Recommend monitoring before repair.

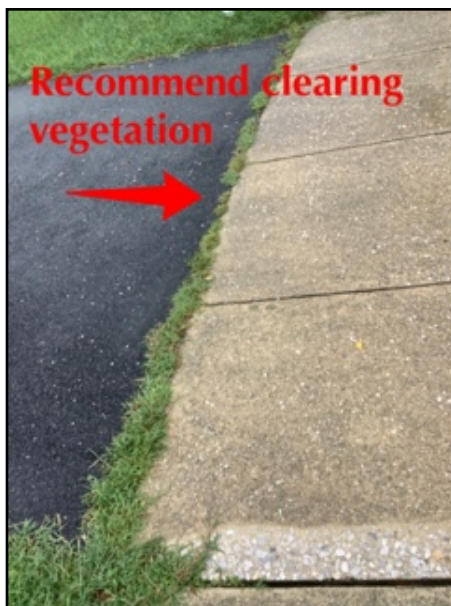
Figure 3-1

Vegetation observed growing in cracks between service walk and driveway. Recommend controlling vegetation growth before it begins to heave and lift concrete sidewalk.

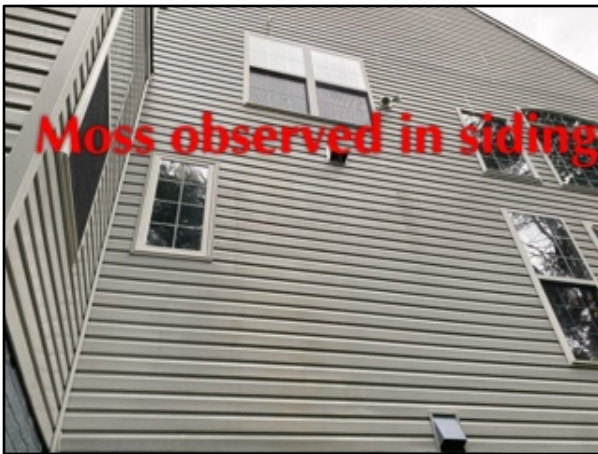
Figure 4-1

Moss and other microbial growth observed on vinyl siding. Recommend cleaning maintenance.

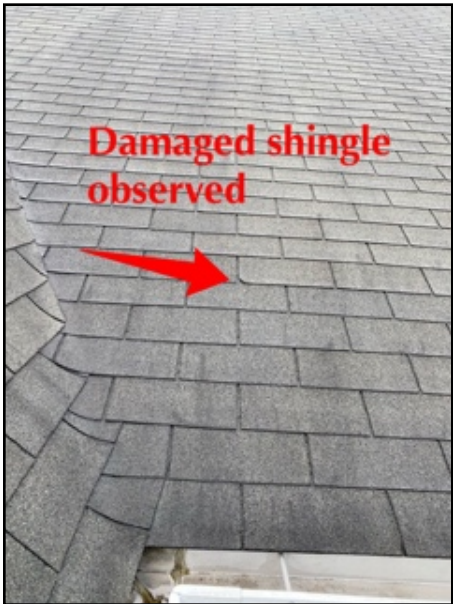
Figure 5-4

Roof was operating as intended at the time of inspection but moss, UV burn spots and a damaged shingle was observed. Since roof is 15 years old, roof replacement is recommended in the coming years.

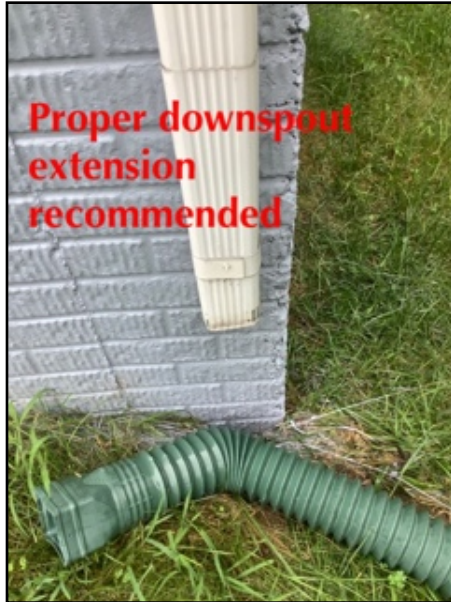
Figure 6-1

Recommend gutter downspout extensions on side of house to divert water a minimum of 4 to 5 feet from foundation.

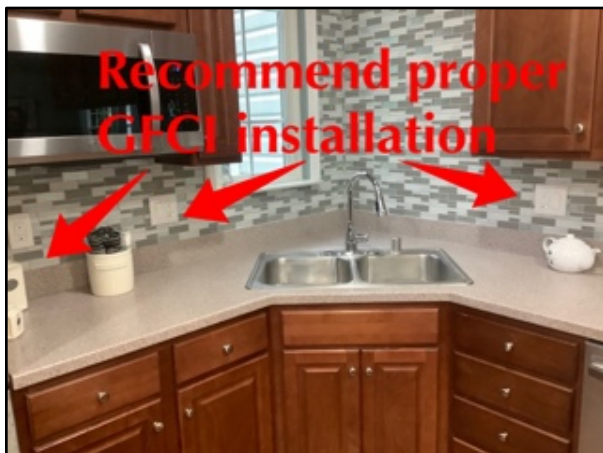
Figure 8-1

GFCI outlets in kitchen are wired together so multiple GFCIs trip at the same time. There should be just one GFCI per circuit. Recommend certified electrician to evaluate and advise proper repair.

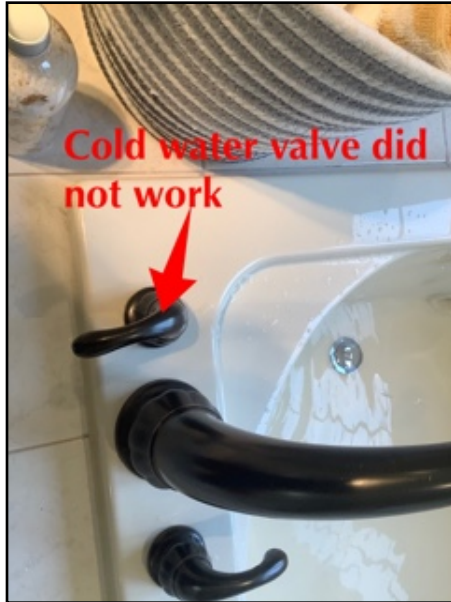
Figure 9-1

Cold water valve in recirculating master bathtub was turned off during inspection. Recommend certified plumber evaluate and advise.

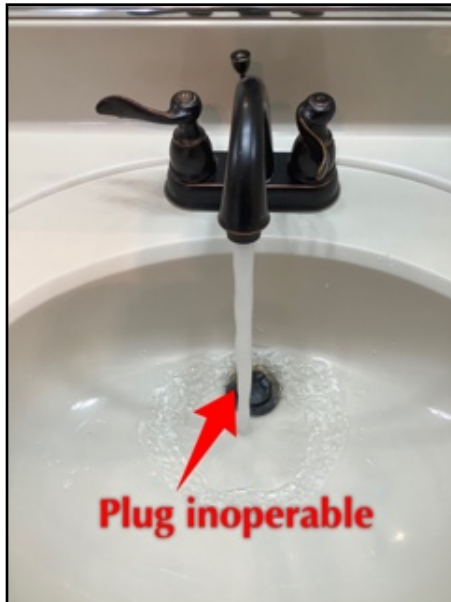
Figure 10-1

Plug inoperable in right side vanity sink in master bath. Recommend repair.

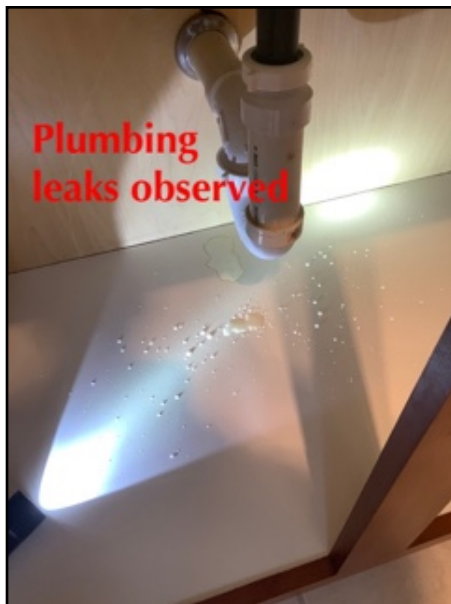
Figure 11-1

Plumbing leak was observed in right side vanity sink drainpipe in master bath. Recommend certified plumber evaluate and advise.

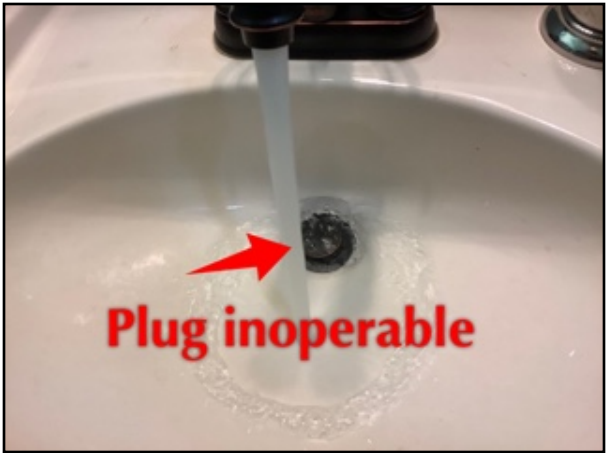
Figure 12-1

Comment 12:
Sink drain plug was inoperable in main floor bathroom vanity sink.
Recommend repair.

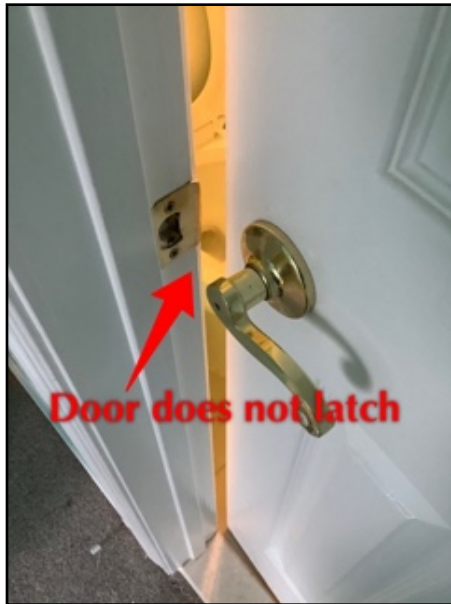
Figure 13-1

Comment 13:
Door strike plate from southeast bedroom to hall bathroom does not line up and door does not latch. Recommend adjustment.

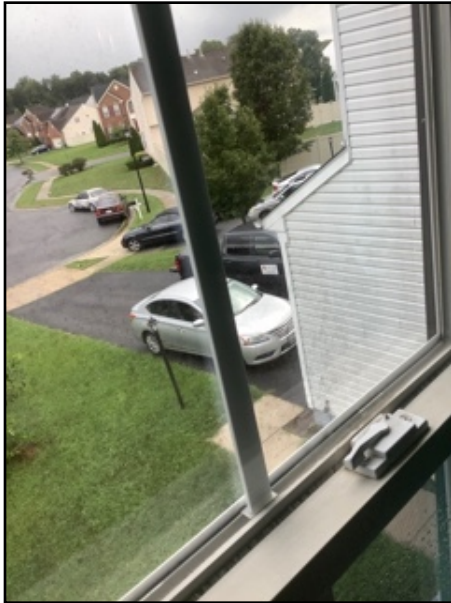
Figure 14-1

Windows in home were found to be showing normal signs of age with some condensation observed at the time of inspection. Recommend budgeting for replacement in the coming years.

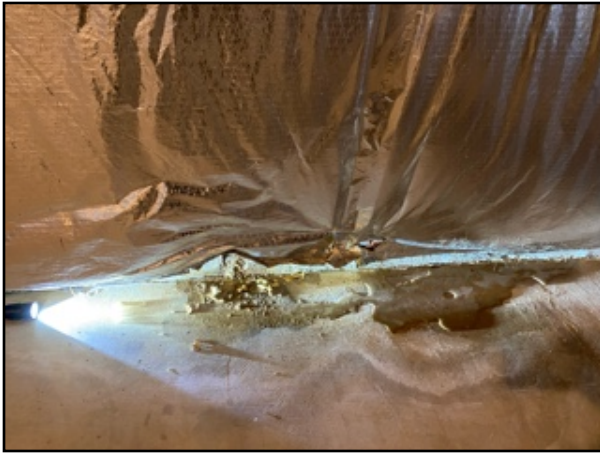
Figure 15-1

Comment 15:
Water was observed entering basement in several areas after heavy rain.
Recommend certified contractor evaluate and advise.

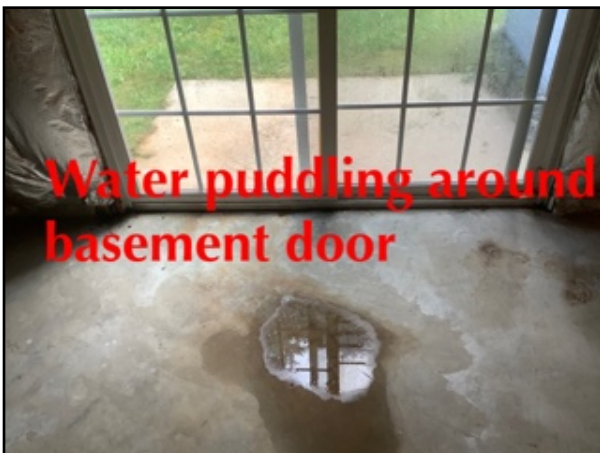
Figure 16-1

Water puddling in front of sliding glass doors was observed in basement. Water stains and wood rot were also observed where sliding glass doors meet the concrete basement floor. Recommend certified contractor evaluate and advise.

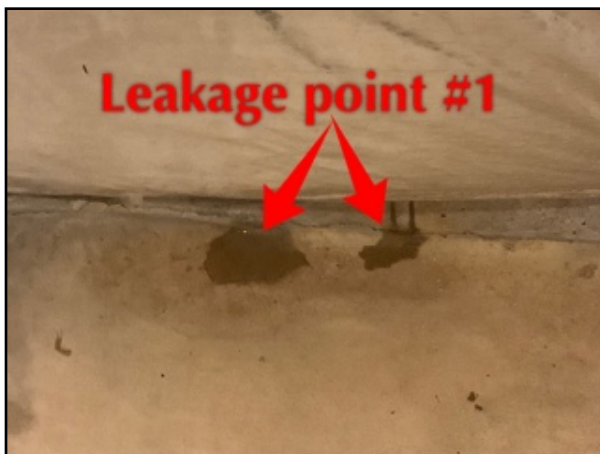
Figure 17-1

Water stains were observed where basement foundation walls meet the basement floor in several areas. Recommend certified contractor evaluate and advise.

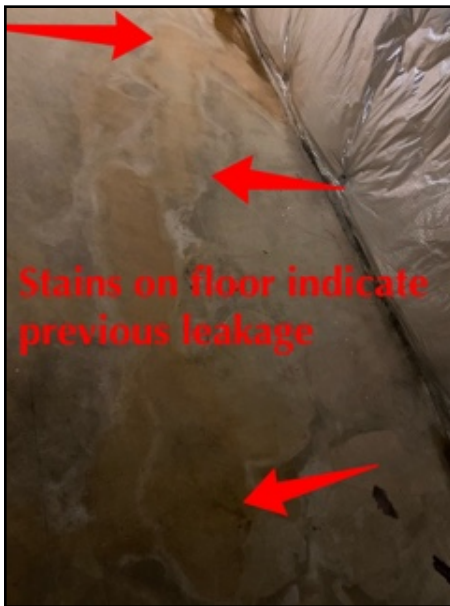
Figure 18-1

A waterproofing specialist was notified to report on the condition of the basement and any repairs that might be required to prevent moisture intrusion. They determined water in the basement is a result of a crack in the basement wall. The repairs include (but are not restricted to) installing a new waterproofing system with 14mil vapor barrier, hydrophobic polyurethane injections and a Rhino concrete crack repair strap.

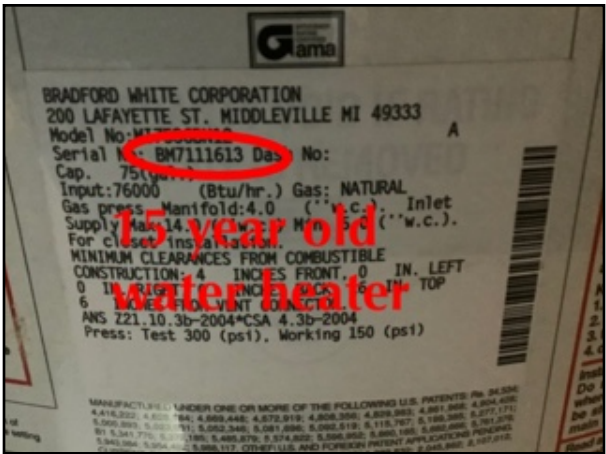
Figure 19-1

Comment 19:
15 year old water heater means that it is approaching the end of its useful life.
Recommend budgeting for replacement in the coming years

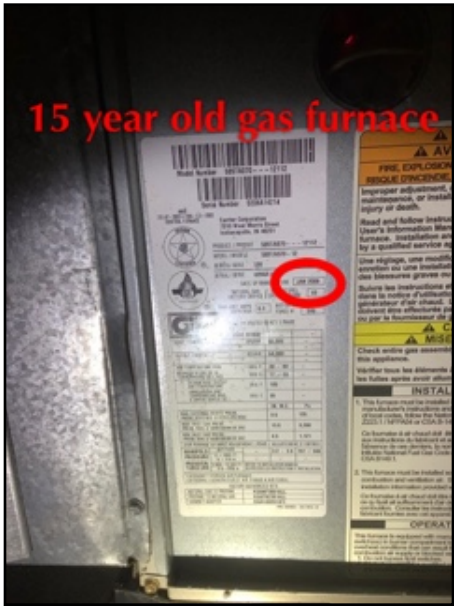
Figure 20-1

Comment 20:
Furnace operated as intended, but at 15 years old it is approaching the end of its useful life. Recommend regular service from a certified technician before closing on the sale of the house and budgeting for replacement in the coming years.

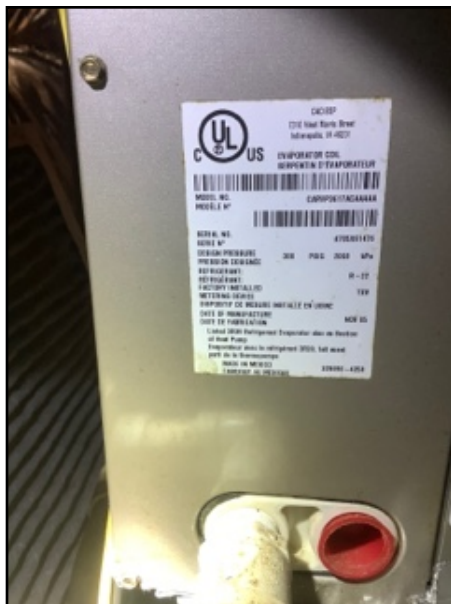
Figure 24-1

15 year old indoor A/C expansion coil in basement means it is approaching the end of its useful life. Recommend regular service from a certified HVAC contractor to extend its life and budgeting for replacement in the coming years.

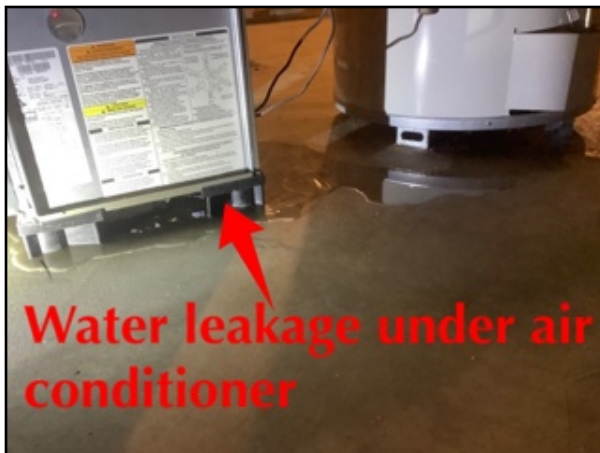
Figure 25-1

A substantial amount of water was found to be puddling on basement floor under air conditioner expansion coil unit. It is recommended that a certified HVAC contractor evaluate and advise on the condition of the air conditioning unit in the basement prior to closing on the sale of the house.

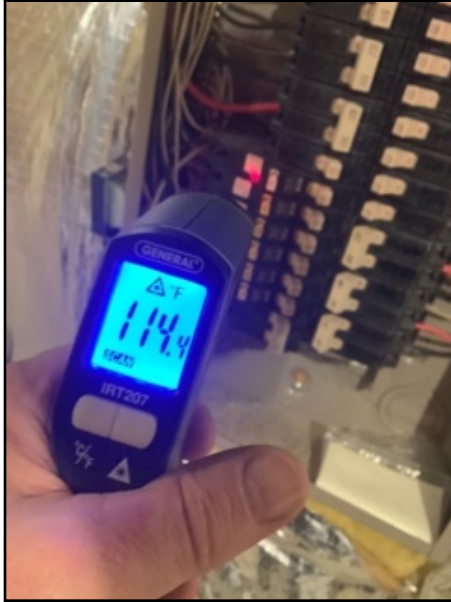
Figure 28-1

While GFCI and AFCI circuit breakers in the main panel were registering high temperatures, they were all within range of manufacturers specifications of 120° or less. The electronics in GFCI/AFCI circuit breakers run hotter than conventional circuit breakers. Monitoring is recommended before contacting certified electrician to evaluate and advise.

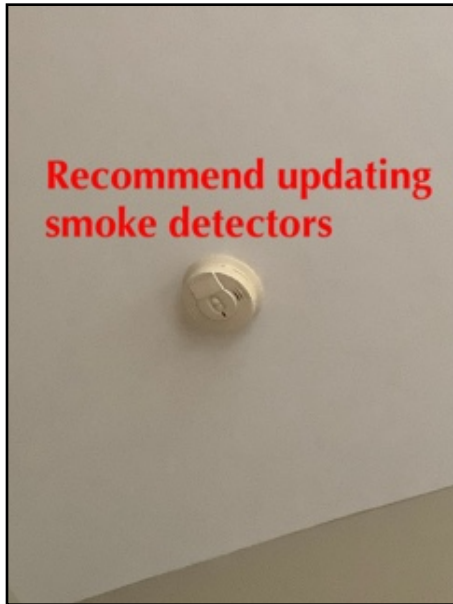
Figure 29-1

Recommend updating smoke detectors throughout the home.

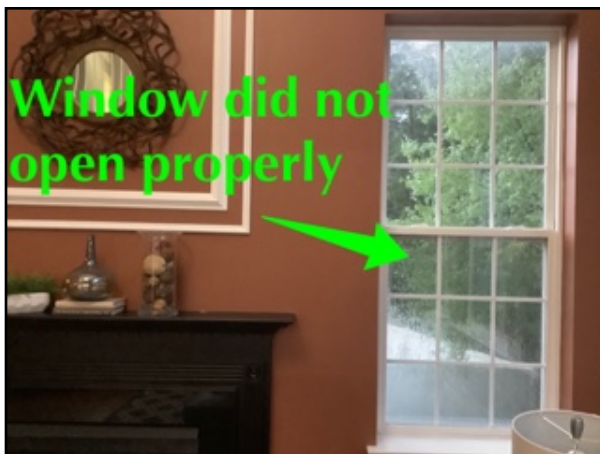
Figure 30-1

Window to the right a fireplace in the family room did not open. Recommend repair.

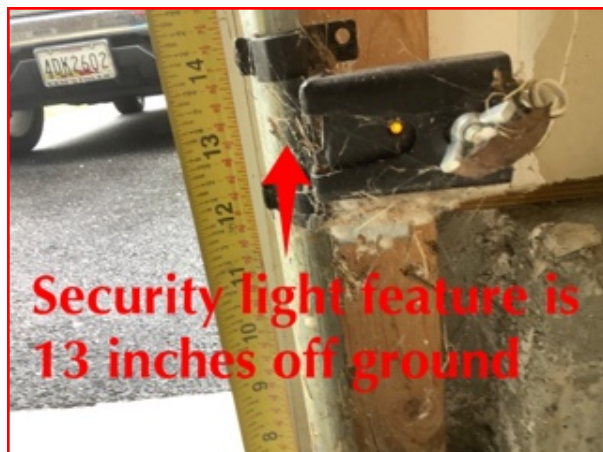
Figure 7-1

7) Garage door light beam security feature was set more than the recommended 6" from ground at the time of inspection. Safety hazard. Recommend repair.

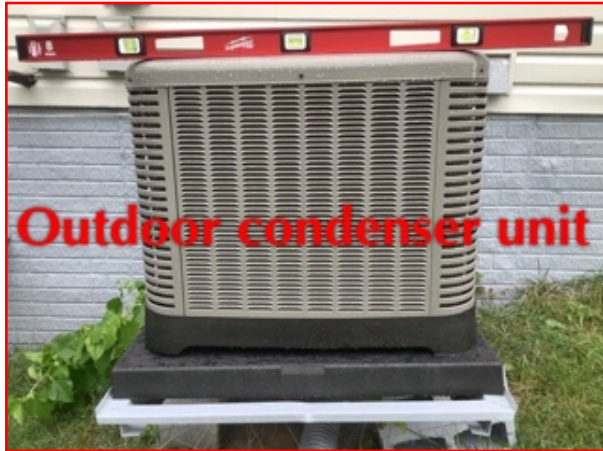
Figure 22-1

21) Condenser unit on side of house was found to be improperly supported and out of level. While additional support measures have been taken in the past to alleviate the problem, it appears to still exist. Recommend certified contractor evaluate and advise.
