OLD LINE
HOME INSPECTIONS

Home Inspection Report

123 Main Street

Inspected on Tue, Mar 23 2021 at 5:00 PM

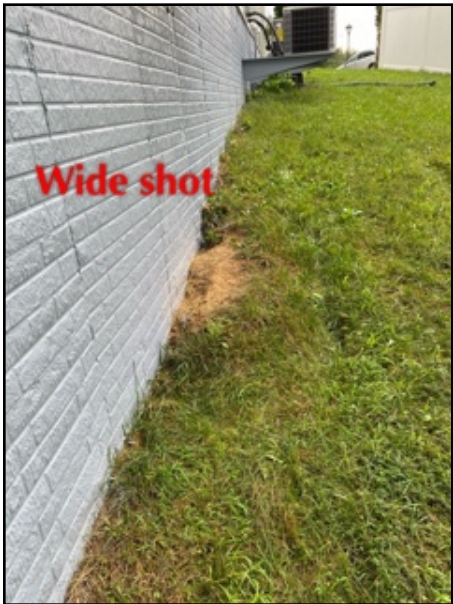
Figure 1-2

Soil has washed away from foundation leaving small holes behind.
Recommend adding fill dirt to divert water and grading soil to slope away from foundation.

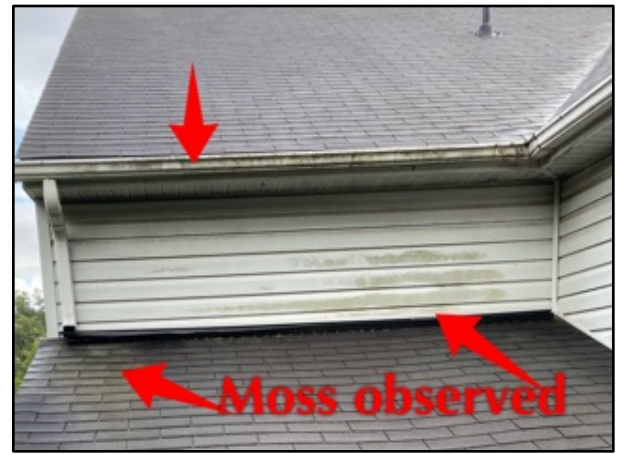
Figure 4-2

Moss and other microbial growth observed on vinyl siding. Recommend cleaning maintenance.

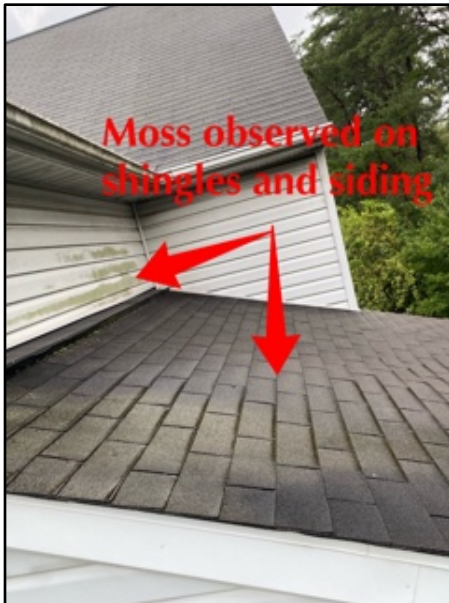
Figure 5-1

Roof was operating as intended at the time of inspection but moss, UV burn spots and a damaged shingle was observed. Since roof is 15 years old, roof replacement is recommended in the coming years.

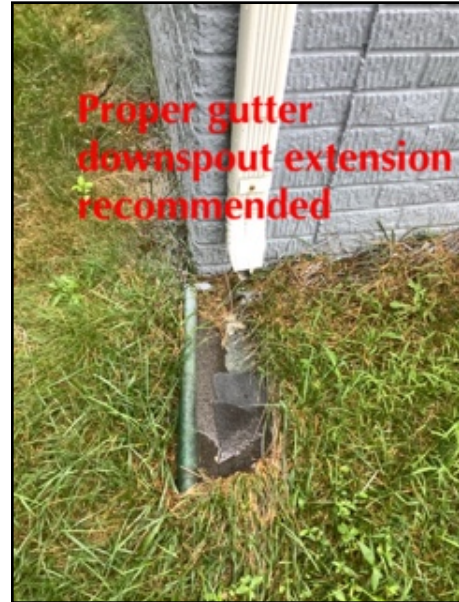
Figure 6-2

Recommend gutter downspout extensions on side of house to divert water a minimum of 4 to 5 feet from foundation.

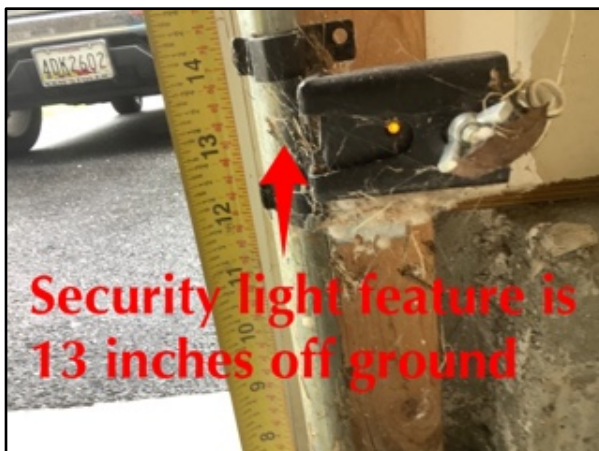
Figure 7-1

Garage door light beam security feature was set more than the recommended 6" from ground at the time of inspection. Safety hazard. Recommend repair.

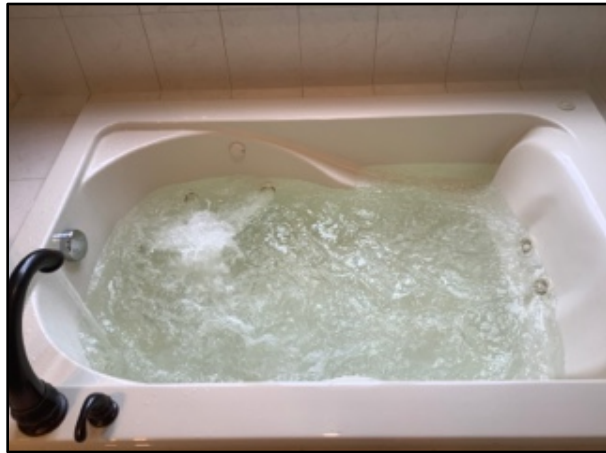
Master
Recessed, Recirculating
Condition: Repair or Replace

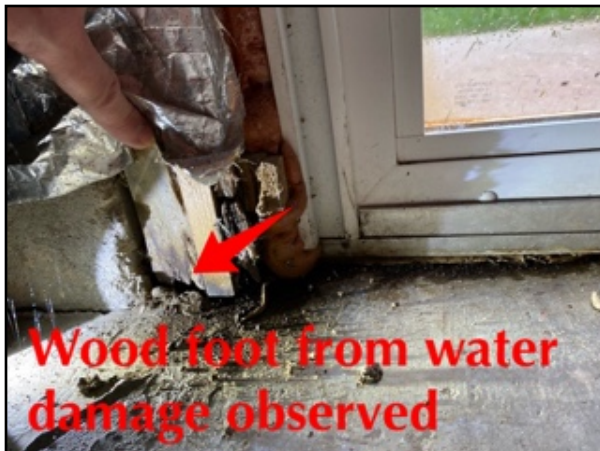
Figure 16-3

Water puddling in front of sliding glass doors was observed in basement. Water stains and wood rot were also observed where sliding glass doors meet the concrete basement floor. Recommend certified contractor evaluate and advise.

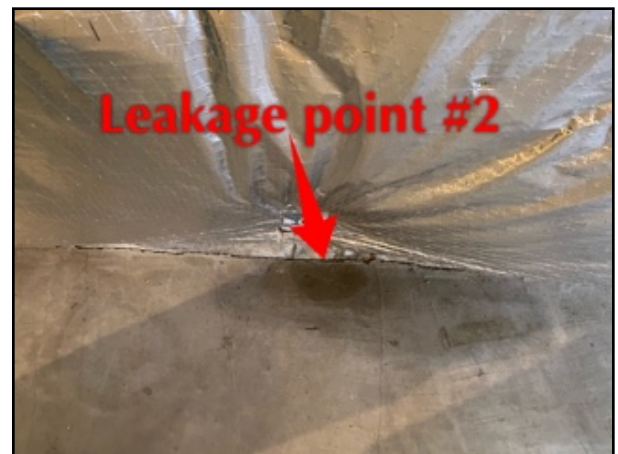
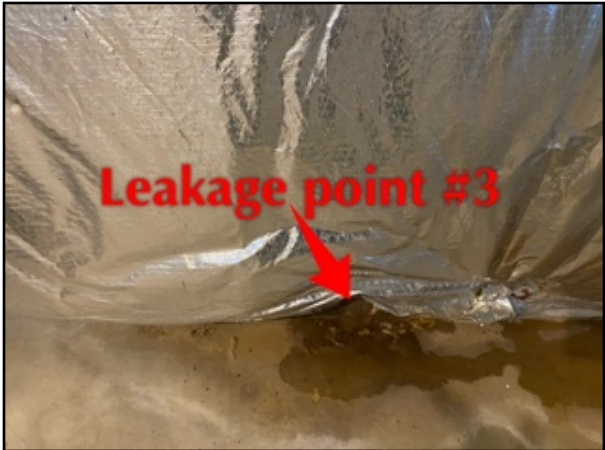
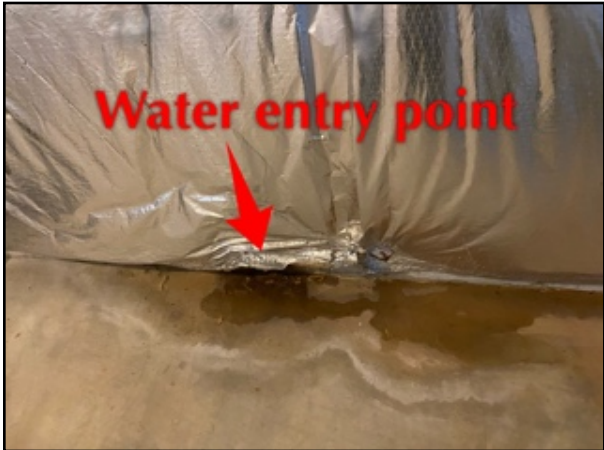
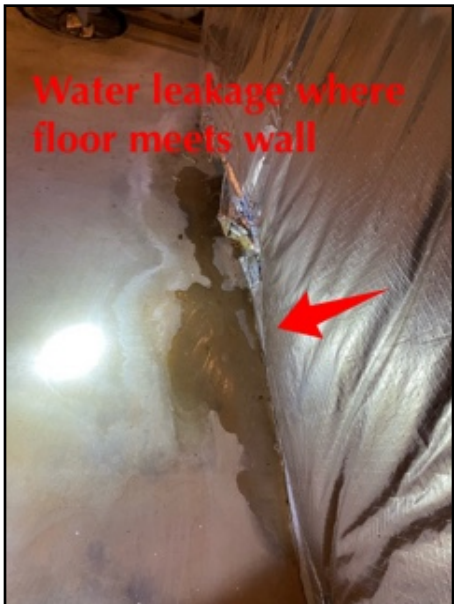
Water stains were observed where basement foundation walls meet the basement floor in several areas. Recommend certified contractor evaluate and advise.

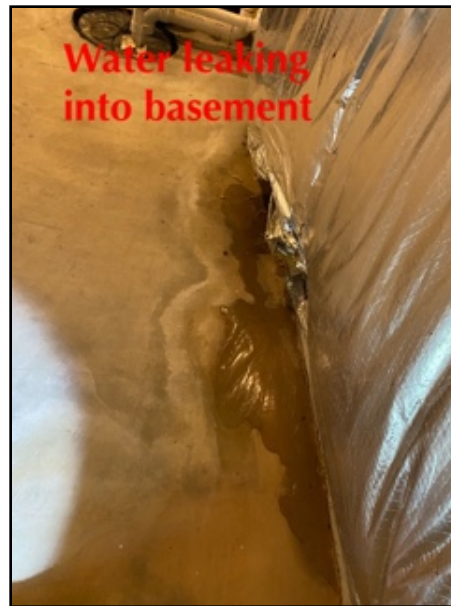
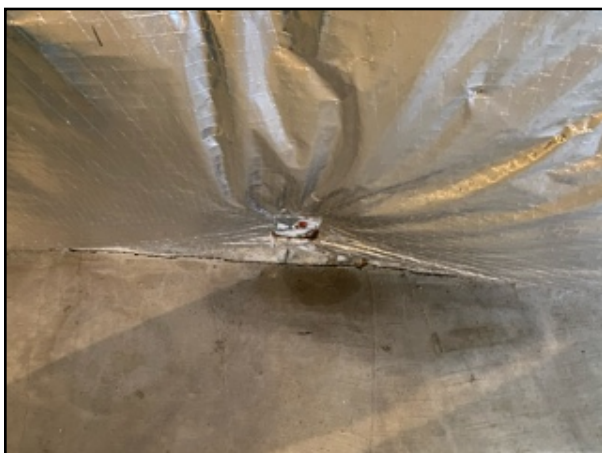
A waterproofing specialist was notified to report on the condition of the basement and any repairs that might be required to prevent moisture intrusion. They determined water in the basement is a result of a crack in the basement wall. The repairs include (but are not restricted to) installing a new waterproofing system with 14mil vapor barrier, hydrophobic polyurethane injections and a Rhino concrete crack repair strap.

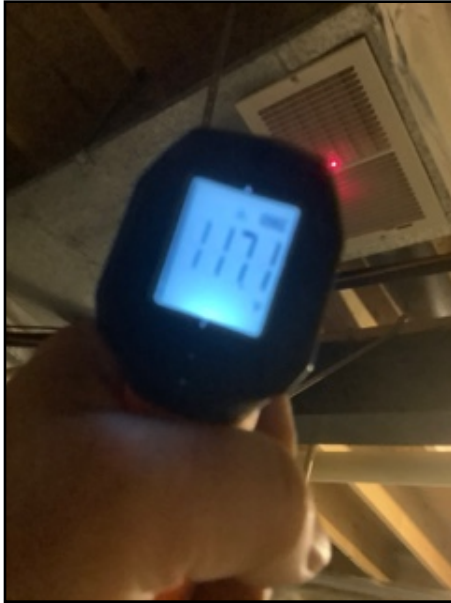
Figure 21-1

117.1° Furnace supply temperature is satisfactory

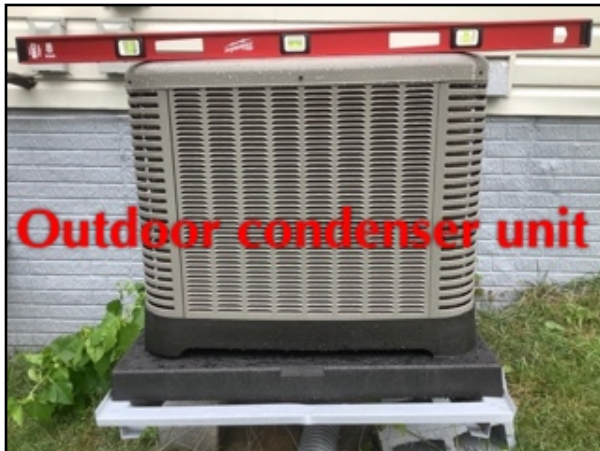
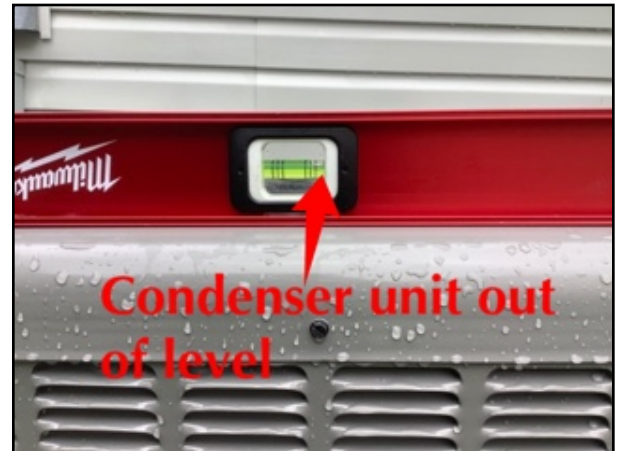
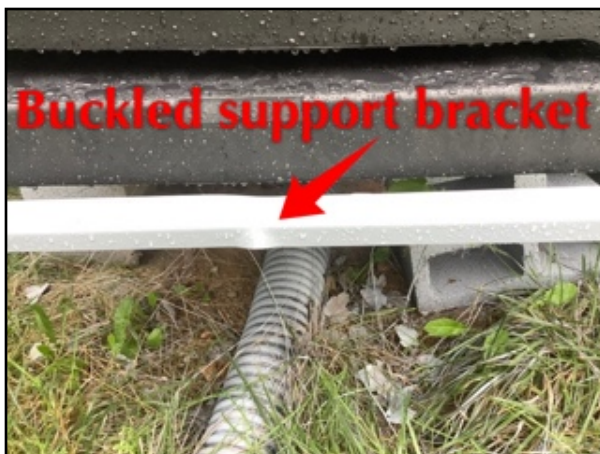
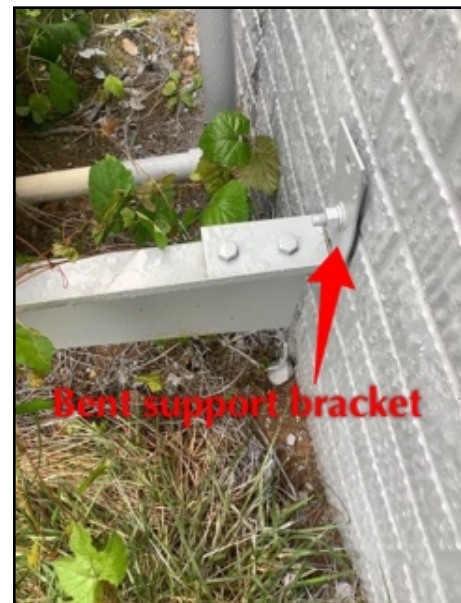
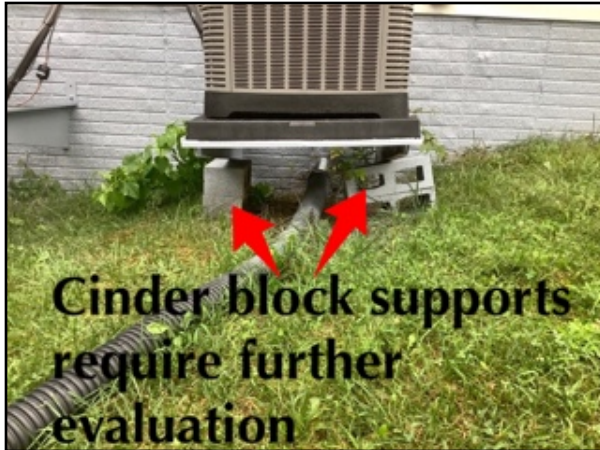
Condenser unit on side of house was found to be improperly supported and out of level. While additional support measures have been taken in the past to alleviate the problem, it appears to still exist. Recommend certified contractor evaluate and advise.

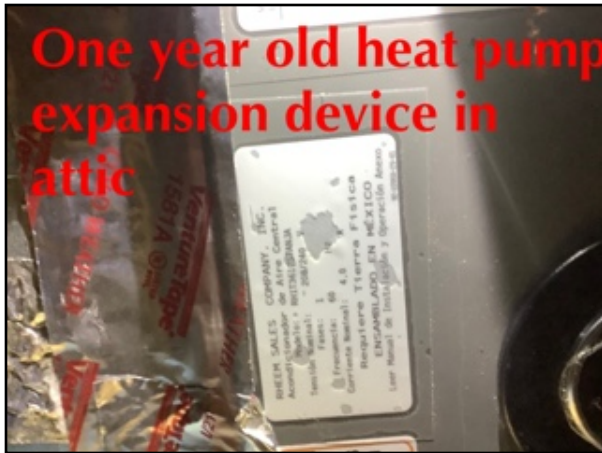
Figure 23-1

One year old heat pump expansion coil in attic.

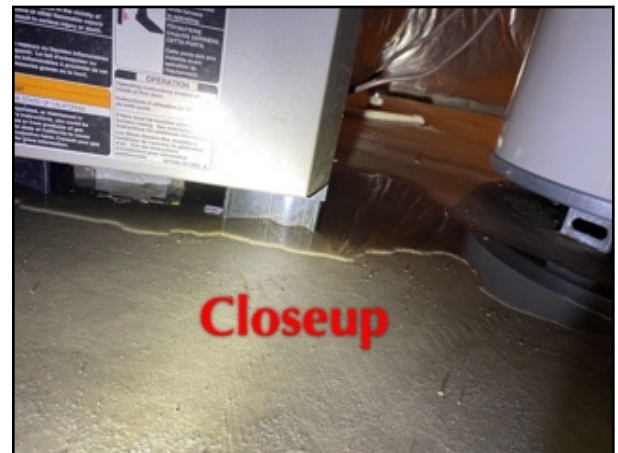
Figure 25-2

A substantial amount of water was found to be puddling on basement floor under air conditioner expansion coil unit. It is recommended that a certified HVAC contractor evaluate and advise on the condition of the air conditioning unit in the basement prior to closing on the sale of the house.

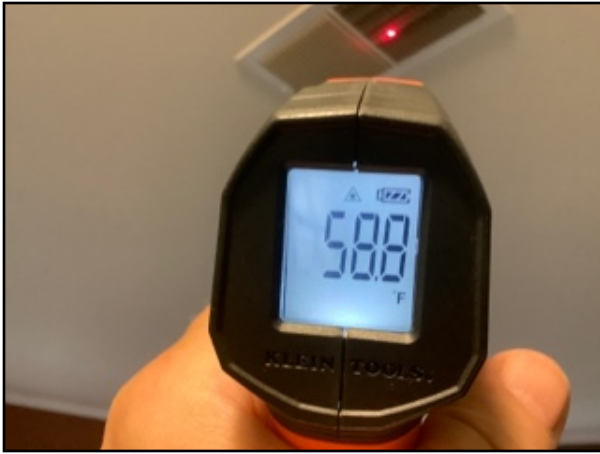
Figure 26-1

Comment 26:
58.8° supply temperature is satisfactory

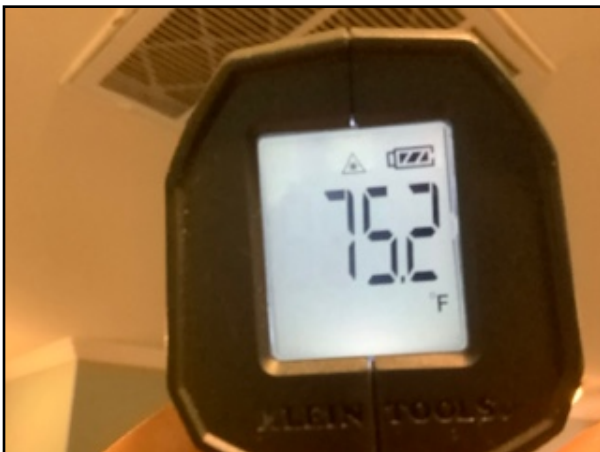
Figure 27-1

Comment 27:
75.2° return temperature

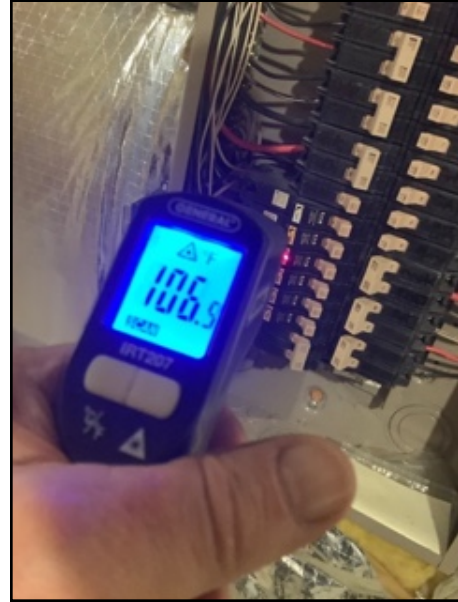
Figure 28-2

While GFCI and AFCI circuit breakers in the main panel were registering high temperatures, they were all within range of manufacturers specifications of 120° or less. The electronics in GFCI/AFCI circuit breakers run hotter than conventional circuit breakers. Monitoring is recommended before contacting certified electrician to evaluate and advise.

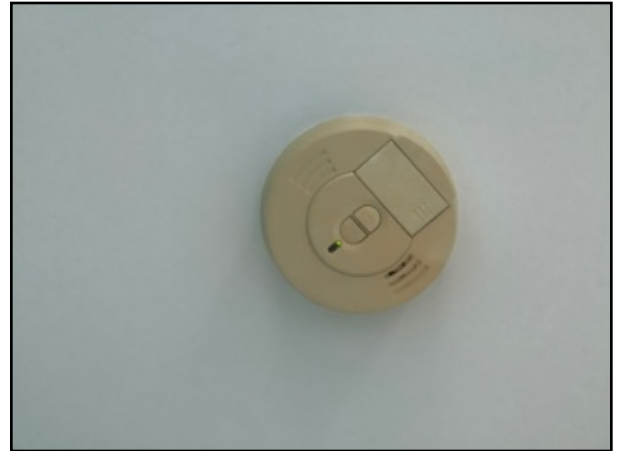
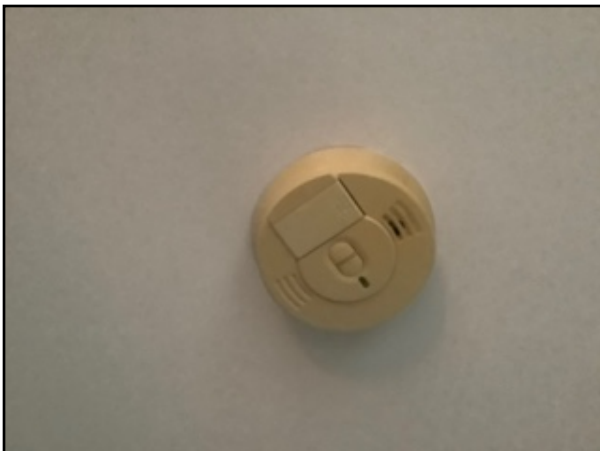
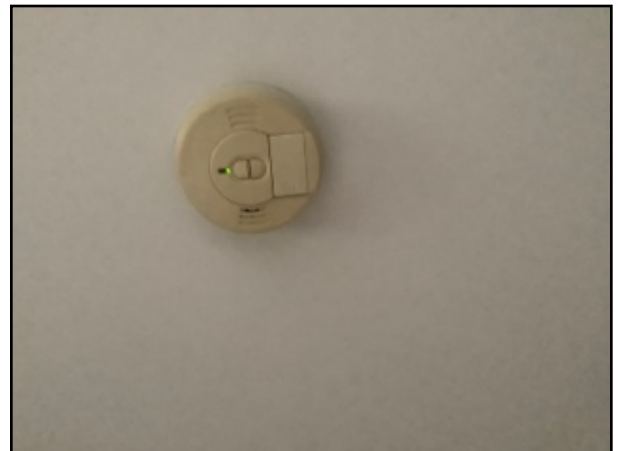
Hard Wired
Condition: Repair or Replace

Recommend updating smoke detectors throughout the home.

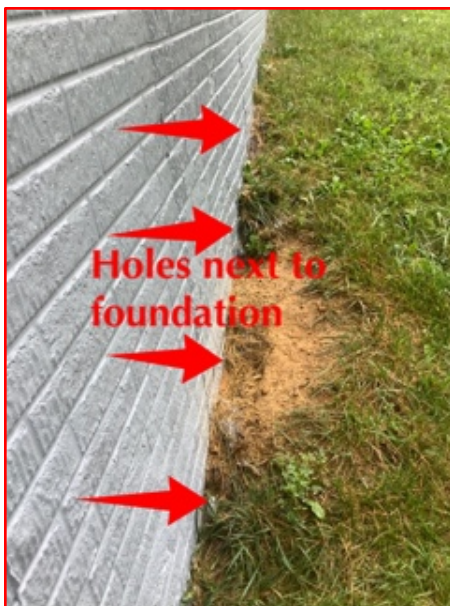
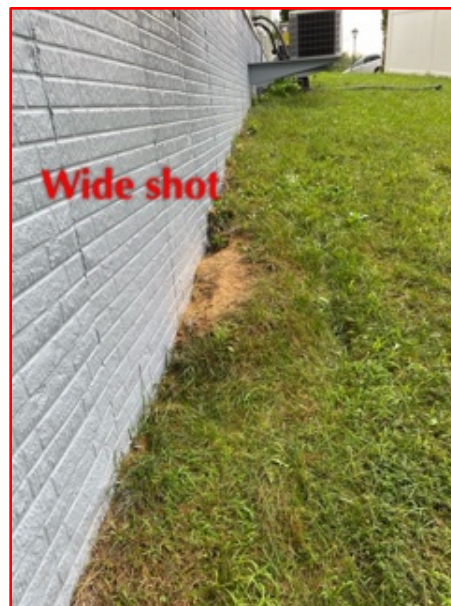
1) Soil has washed away from foundation leaving small holes behind. Recommend adding fill dirt to divert water and grading soil to slope away from foundation.

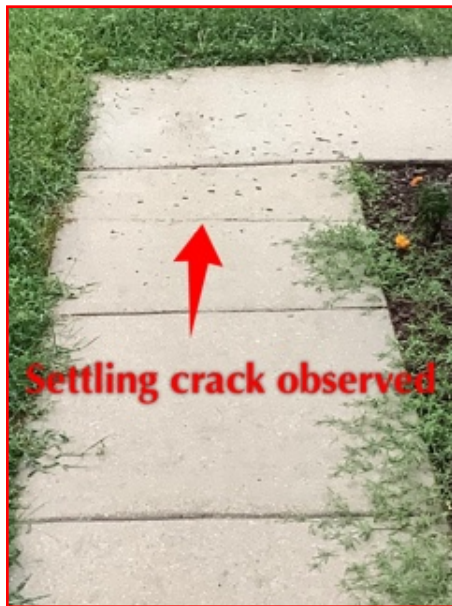
Figure 2-1

2) Walkway in front of house has typical settlement cracking. Recommend monitoring before repair.

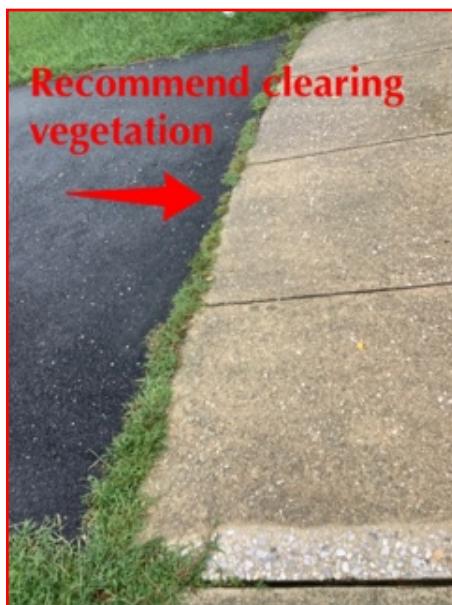
Figure 3-1

3) Vegetation observed growing in cracks between service walk and driveway. Recommend controlling vegetation growth before it begins to heave and lift concrete sidewalk.

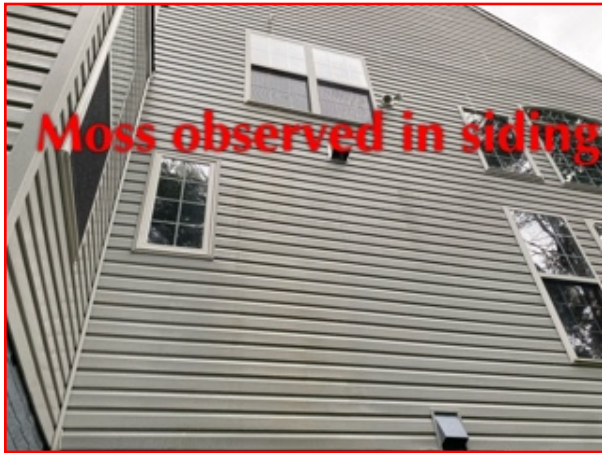
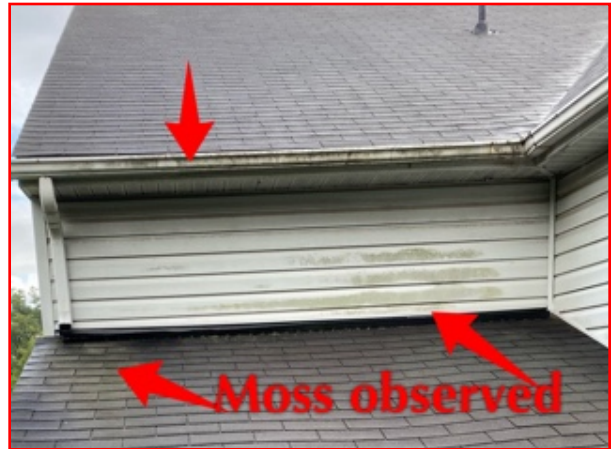
4) Moss and other microbial growth observed on vinyl siding. Recommend cleaning maintenance.

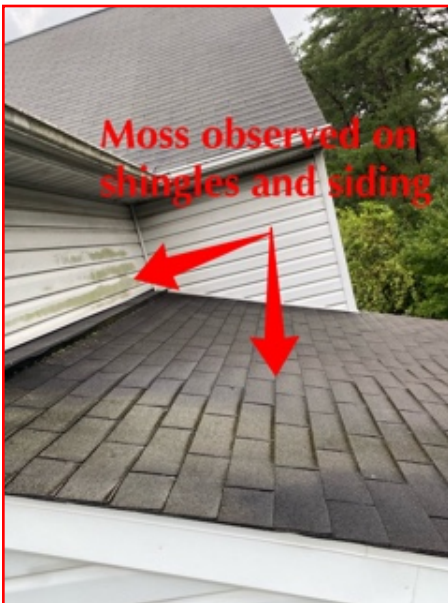
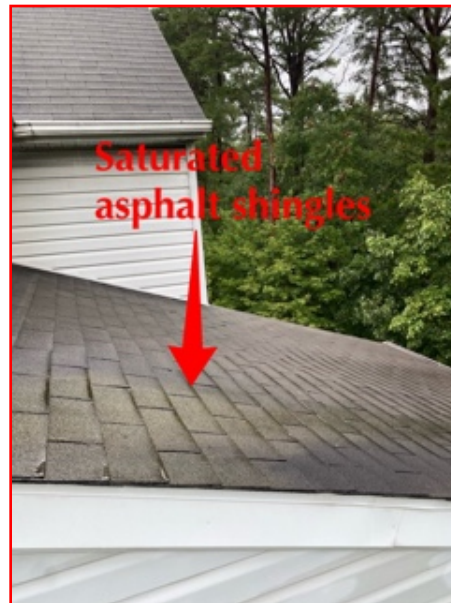
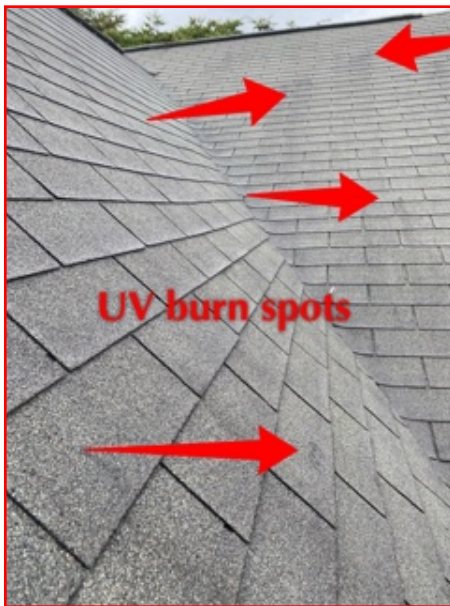
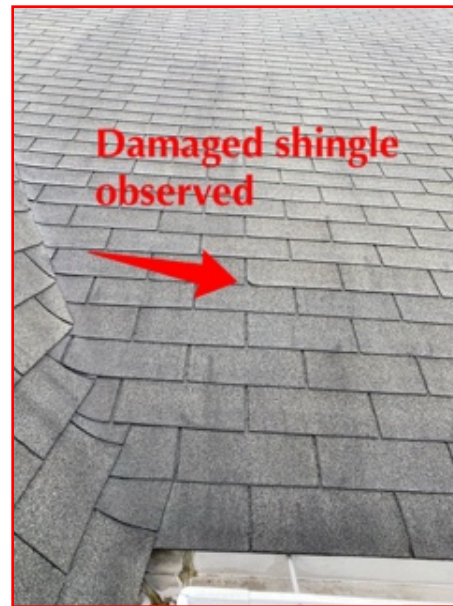
5) Roof was operating as intended at the time of inspection but moss, UV burn spots and a damaged shingle was observed. Since roof is 15 years old, roof replacement is recommended in the coming years.

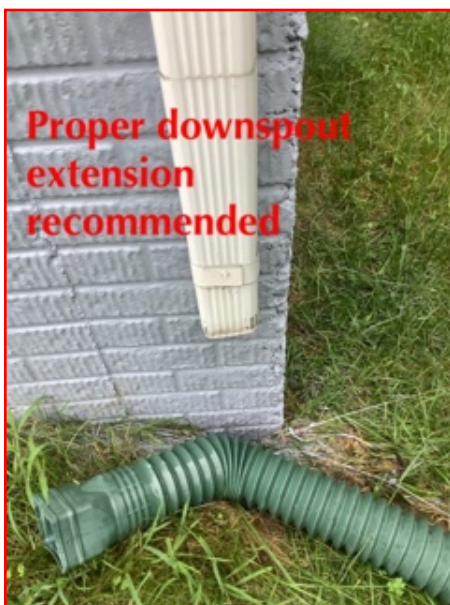
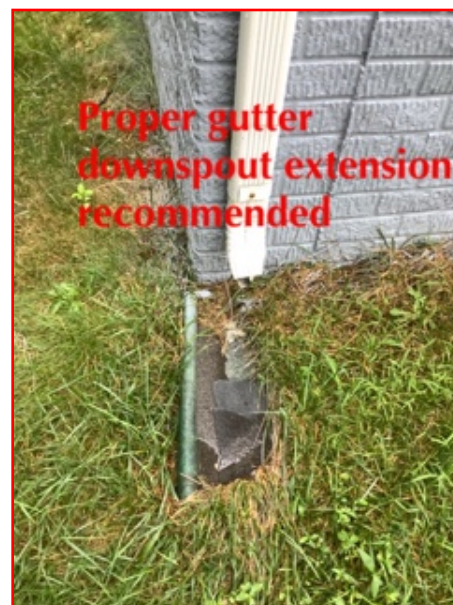
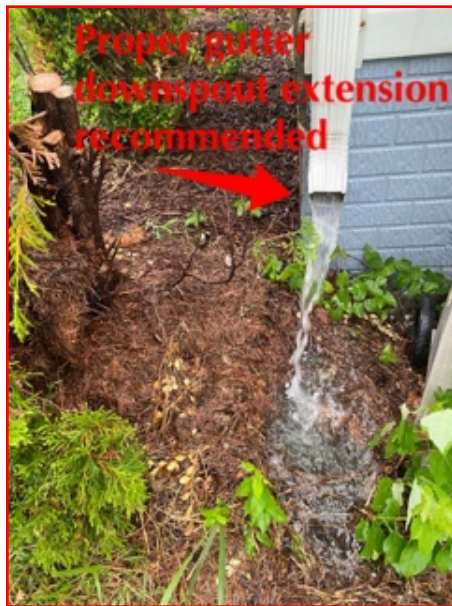
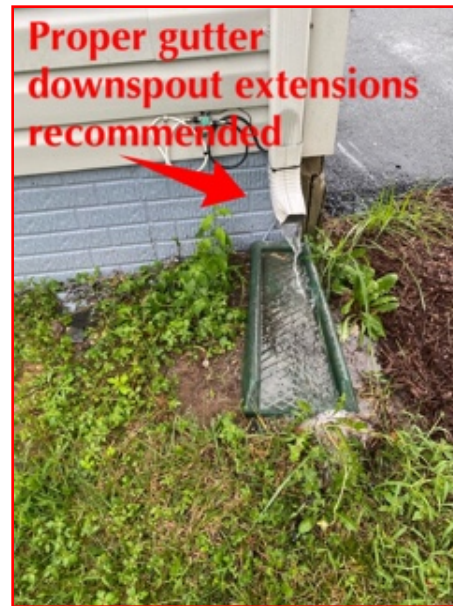
6) Recommend gutter downspout extensions on side of house to divert water a minimum of 4 to 5 feet from foundation.

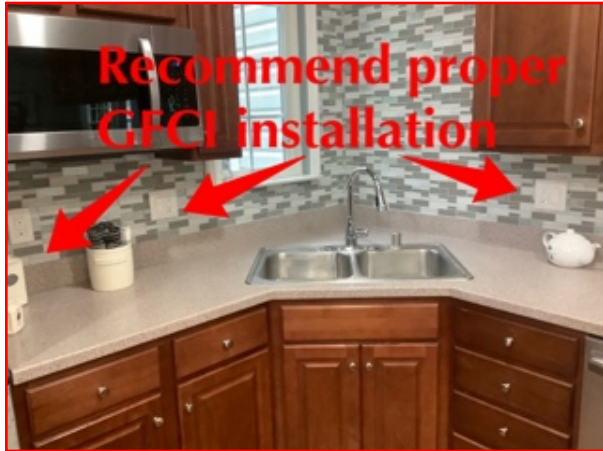
Figure 8-1

8) GFCI outlets in kitchen are wired together so multiple GFCIs trip at the same time. There should be just one GFCI per circuit. Recommend certified electrician to evaluate and advise proper repair.

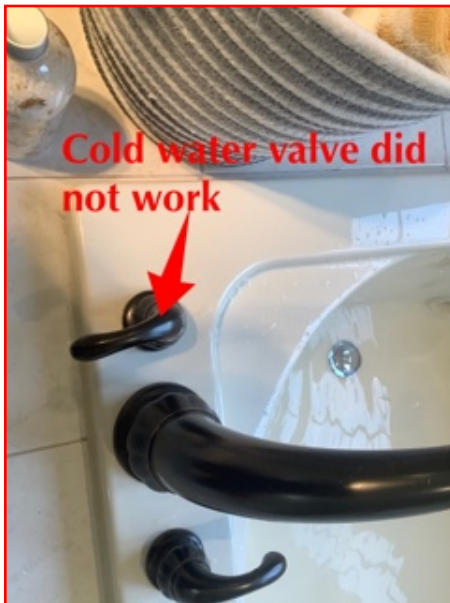
Figure 9-1

9) Cold water valve in recirculating master bathtub was turned off during inspection. Recommend certified plumber evaluate and advise.

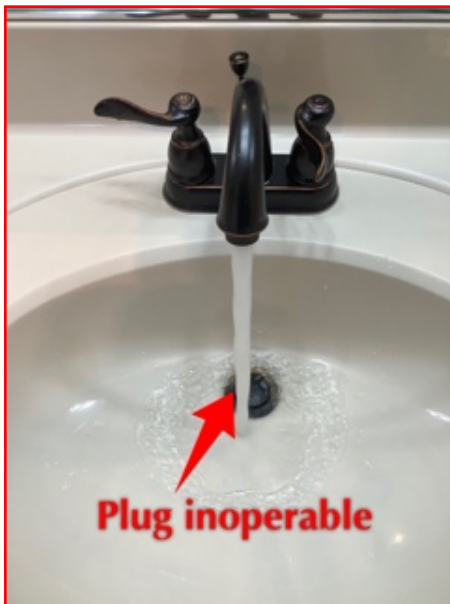
Figure 10-1

10) Plug inoperable in right side vanity sink in master bath. Recommend repair.

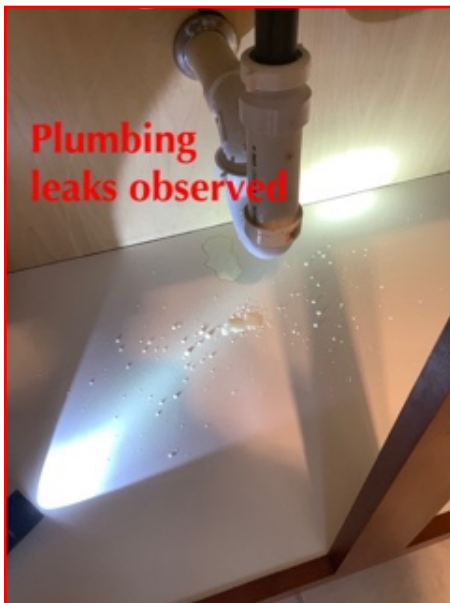
Figure 11-1

11) Plumbing leak was observed in right side vanity sink drainpipe in master bath. Recommend certified plumber evaluate and advise.

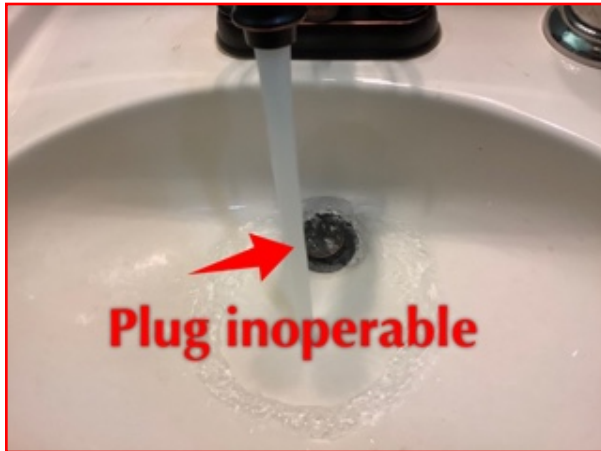
Figure 12-1

12) Sink drain plug was inoperable in main floor bathroom vanity sink. Recommend repair.

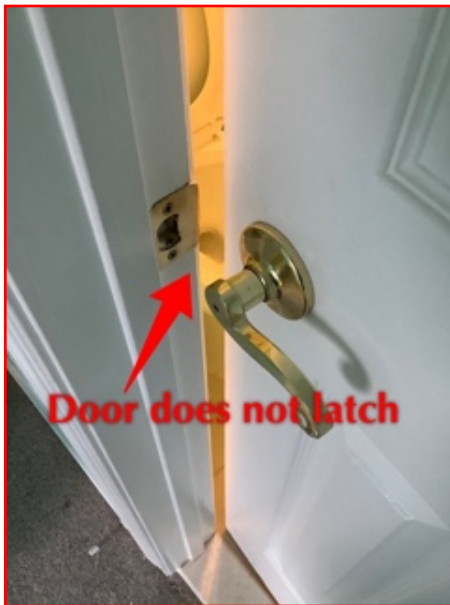
Figure 13-1

13) Door strike plate from southeast bedroom to hall bathroom does not line up and door does not latch. Recommend adjustment.

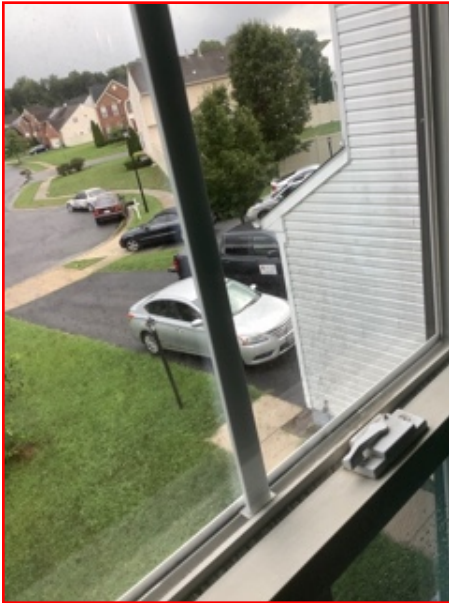
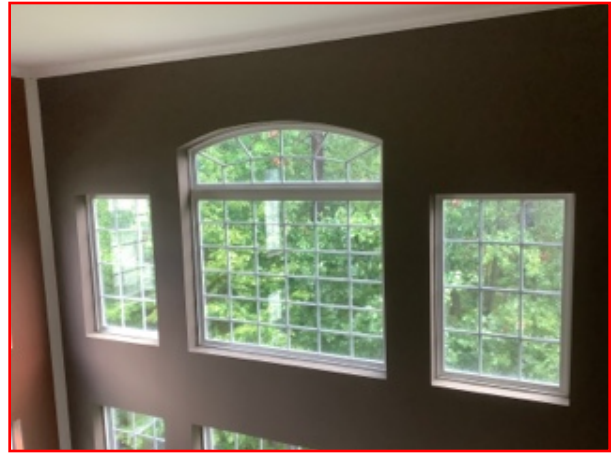
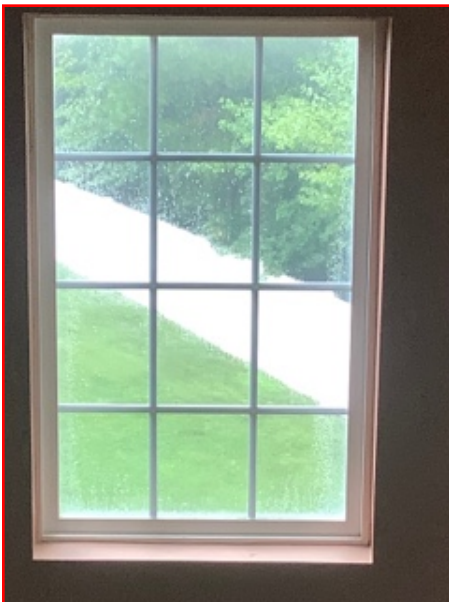
14) Windows in home were found to be showing normal signs of age with some condensation observed at the time of inspection. Recommend budgeting for replacement in the coming years.

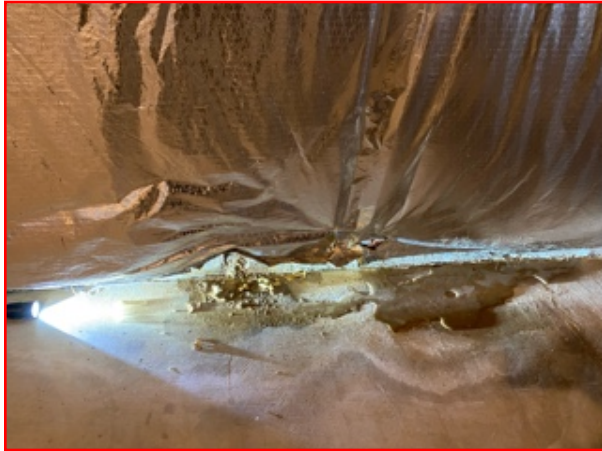
Figure 15-1

15) Water was observed entering basement in several areas after heavy rain. Recommend certified contractor evaluate and advise.

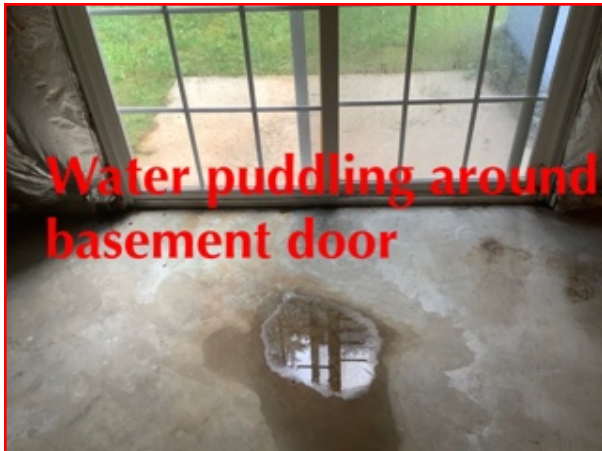
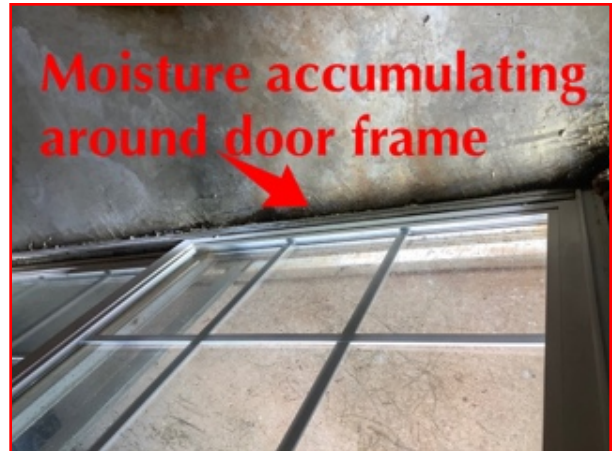
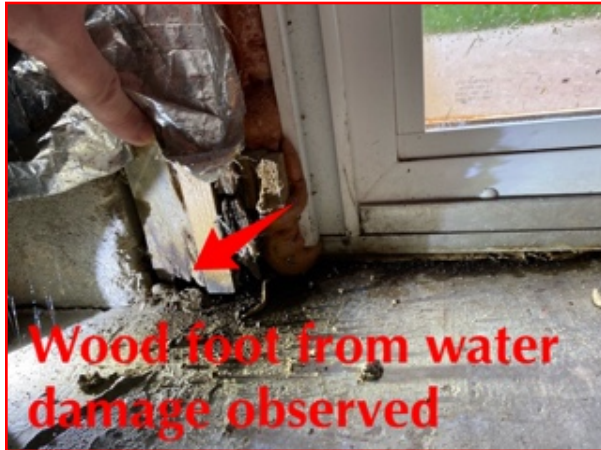
16) Water puddling in front of sliding glass doors was observed in basement. Water stains and wood rot were also observed where sliding glass doors meet the concrete basement floor. Recommend certified contractor evaluate and advise.

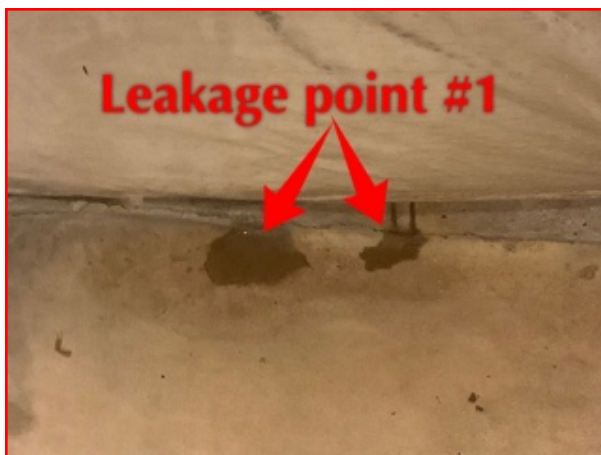
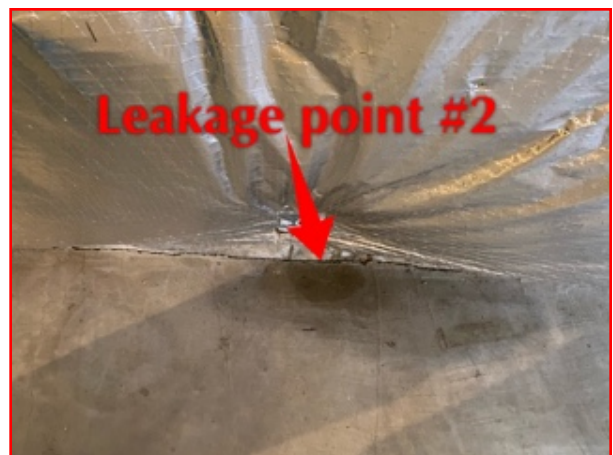
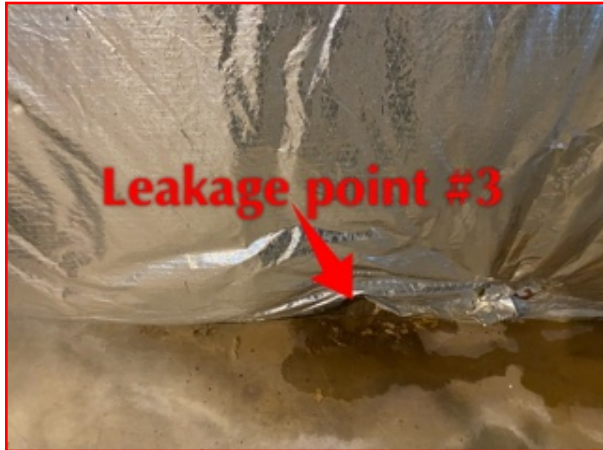
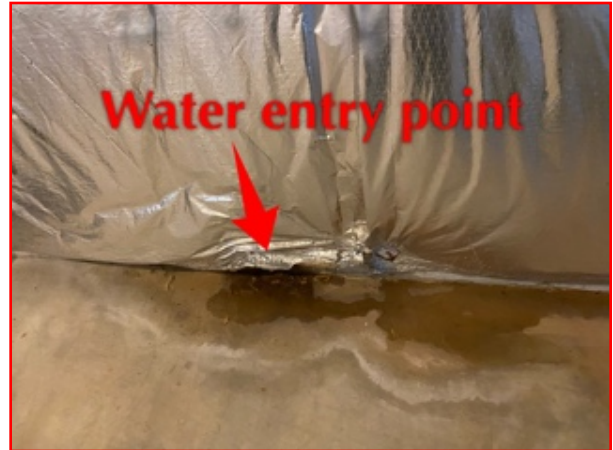
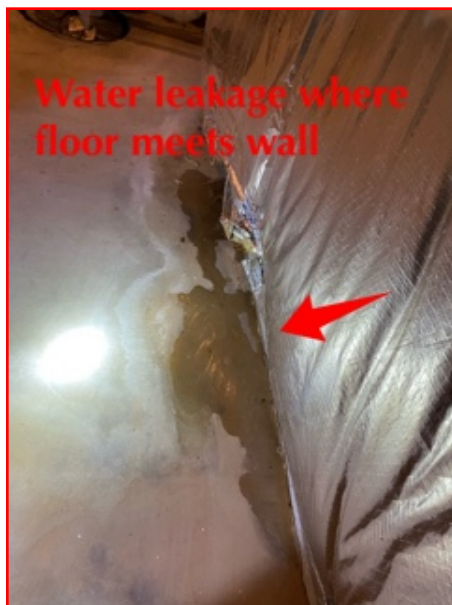
17) Water stains were observed where basement foundation walls meet the basement floor in several areas. Recommend certified contractor evaluate and advise.

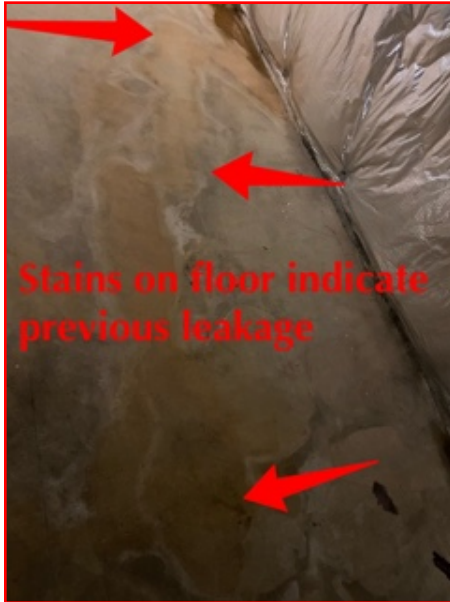
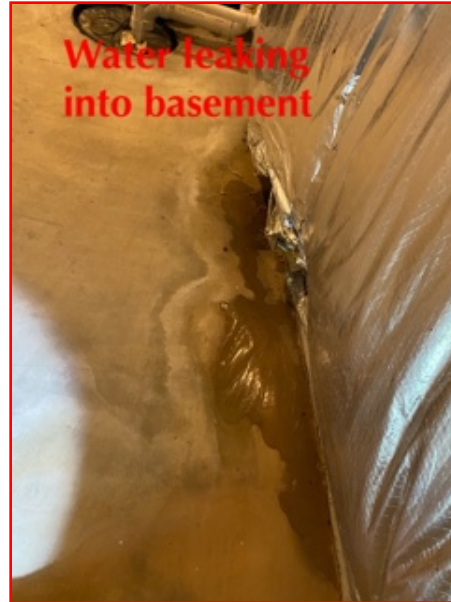
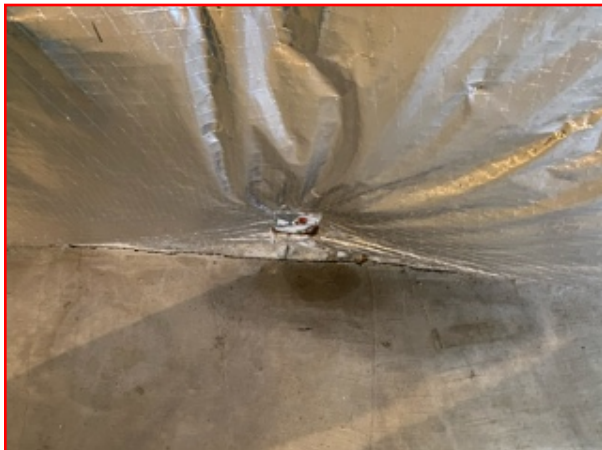
18) A waterproofing specialist was notified to report on the condition of the basement and any repairs that might be required to prevent moisture intrusion. They determined water in the basement is a result of a crack in the basement wall. The repairs include (but are not restricted to) installing a new waterproofing system with 14mil vapor barrier, hydrophobic polyurethane injections and a Rhino concrete crack repair strap.

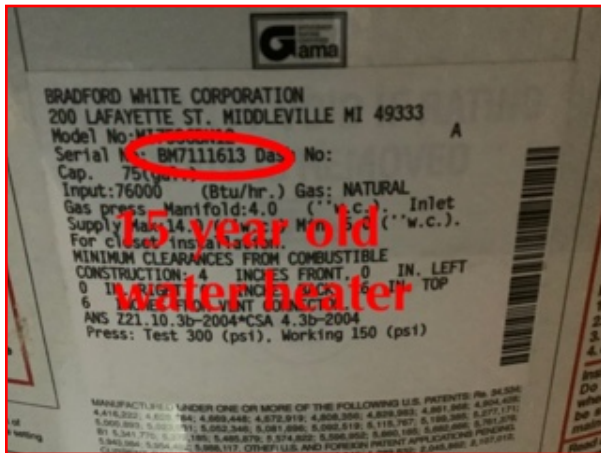
Figure 19-1

19) 15 year old water heater means that it is approaching the end of its useful life. Recommend budgeting for replacement in the coming years

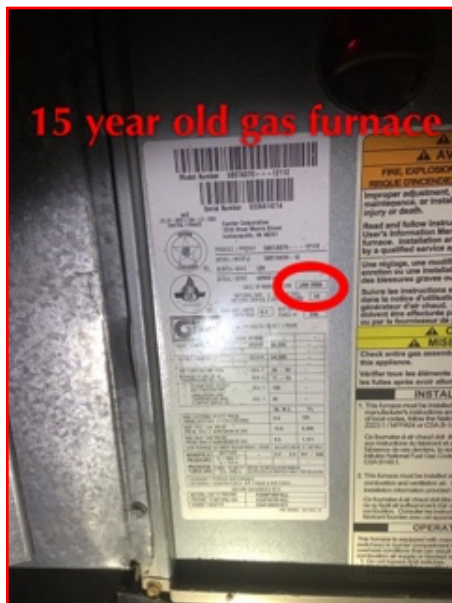
Figure 20-1

Comment 20:
Furnace operated as intended, but at 15 years old it is approaching the end of its useful life. Recommend regular service from a certified technician before closing on the sale of the house and budgeting for replacement in the coming years.

20) Furnace operated as intended, but at 15 years old it is approaching the end of its useful life. Recommend regular service from a certified technician before closing on the sale of the house and budgeting for replacement in the coming years.

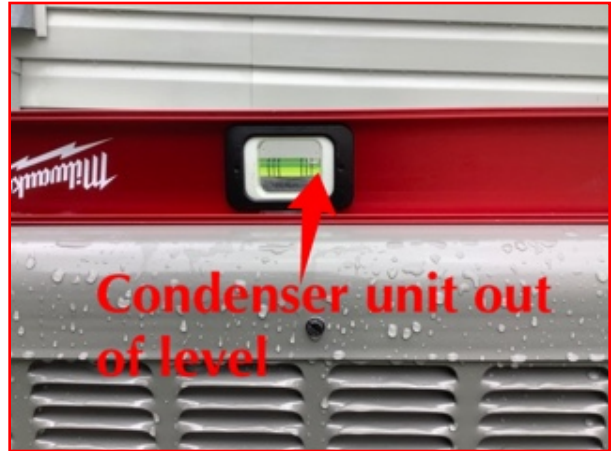
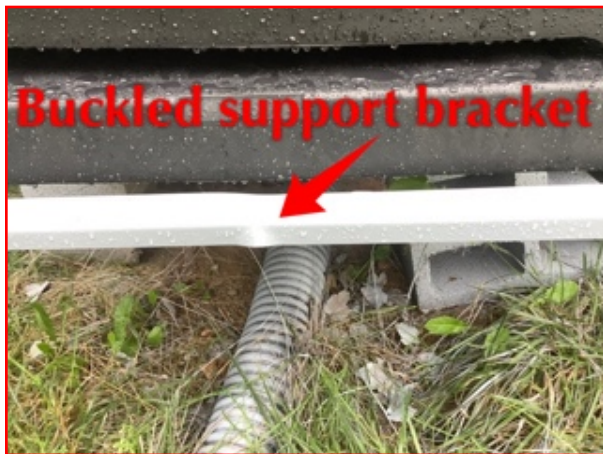
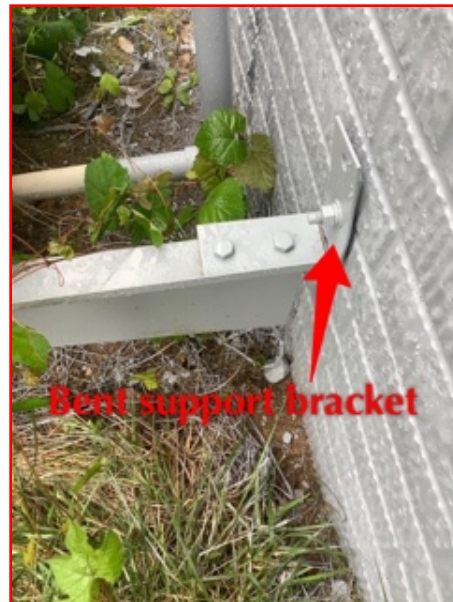
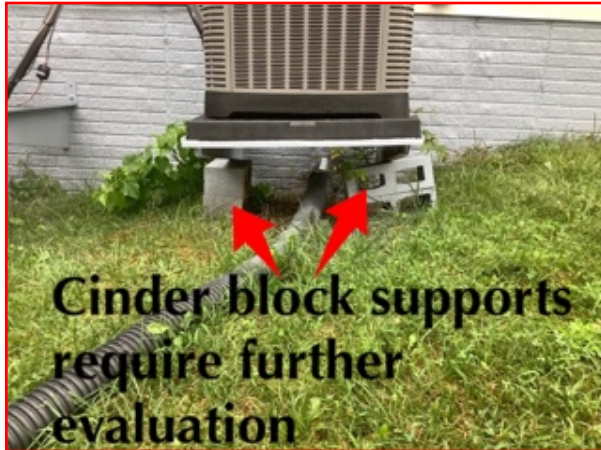
21) Condenser unit on side of house was found to be improperly supported and out of level. While additional support measures have been taken in the past to alleviate the problem, it appears to still exist. Recommend certified contractor evaluate and advise.

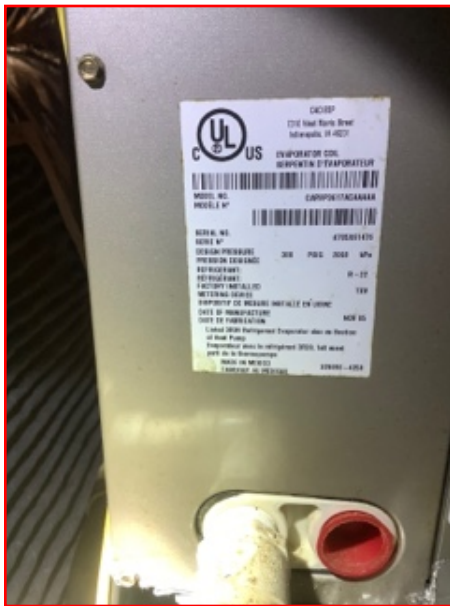
Figure 24-1

15 year old indoor A/C expansion coil in basement means it is approaching the end of its useful life. Recommend regular service from a certified HVAC contractor to extend its life and budgeting for replacement in the coming years.

22) 15 year old indoor A/C expansion coil in basement means it is approaching the end of its useful life. Recommend regular service from a certified HVAC contractor to extend its life and budgeting for replacement in the coming years.

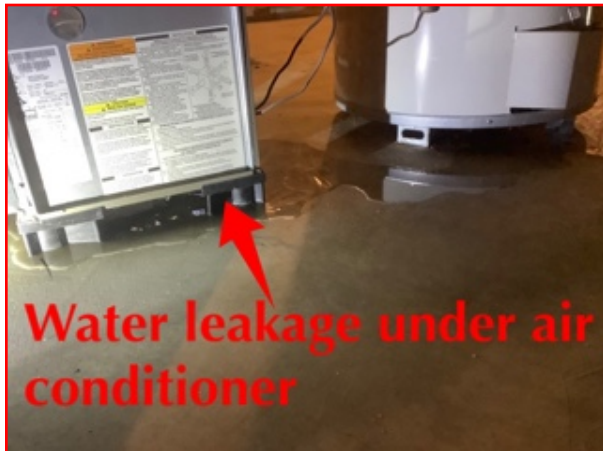
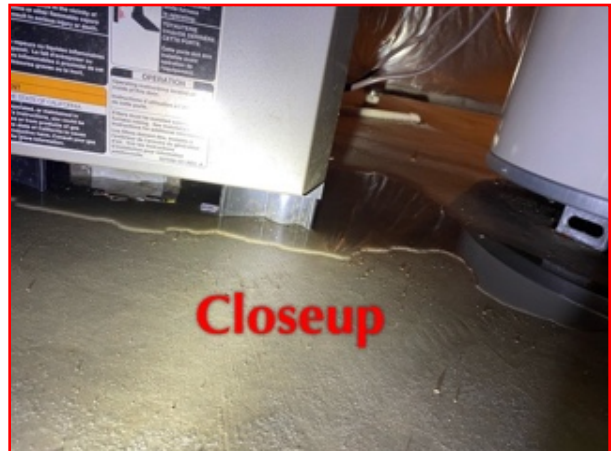
23) A substantial amount of water was found to be puddling on basement floor under air conditioner expansion coil unit. It is recommended that a certified HVAC contractor evaluate and advise on the condition of the air conditioning unit in the basement prior to closing on the sale of the house.

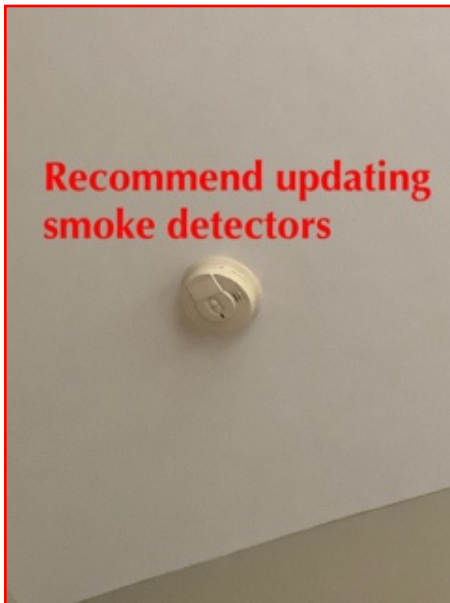
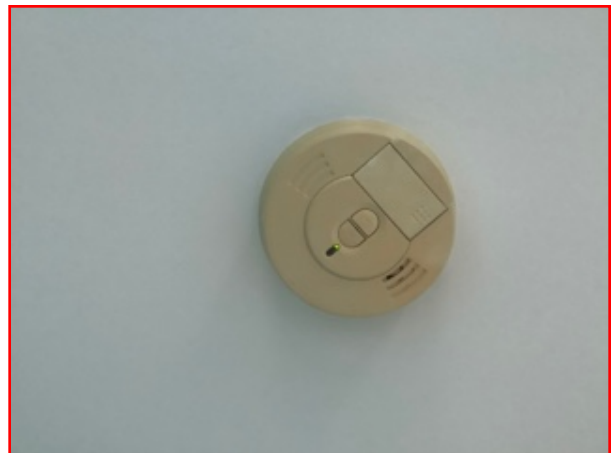
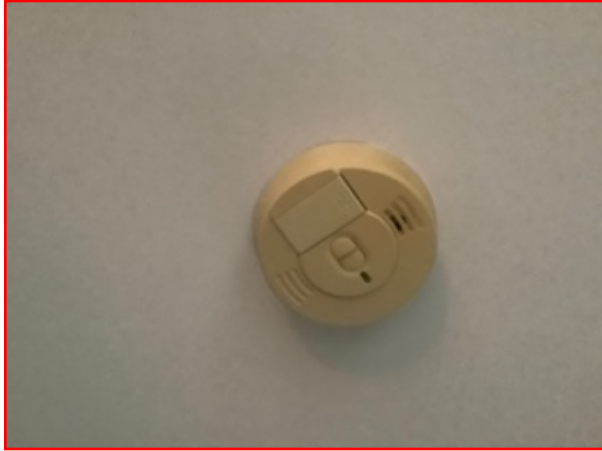
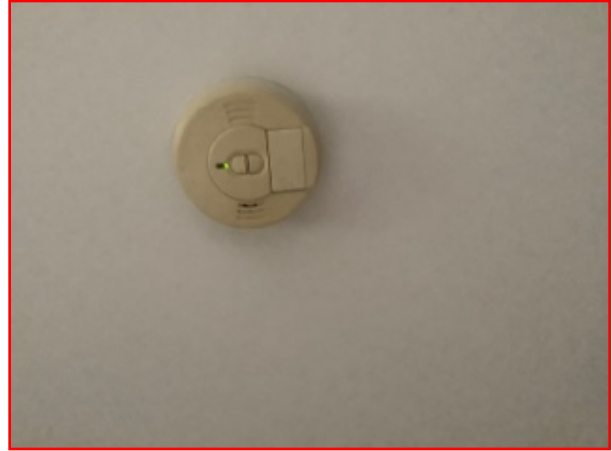
24) Recommend updating smoke detectors throughout the home.

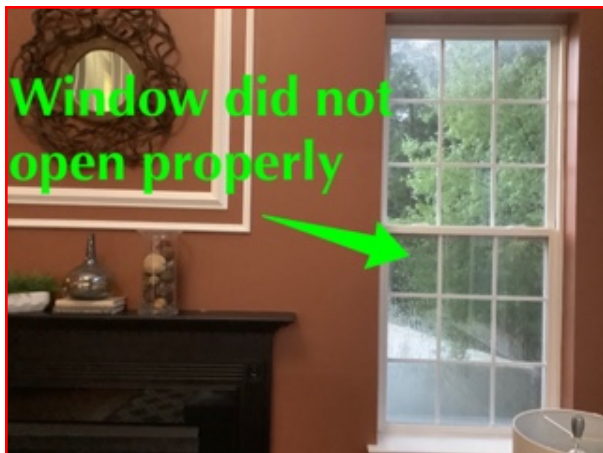
Figure 30-1

Window to the right a fireplace in the family room did not open. Recommend repair.

25) Window to the right a fireplace in the family room did not open. Recommend repair.
